## **Town of Whitby Report**

**Report to:** Operations Committee  
**Date of meeting:** September 3, 2014  
**Department:** Community and Marketing Services Department  
**Report Number:** CMS 45-14  
**File Number(s):** n/a

### **Report Title: Iroquois Park Sports Centre Main Entry**

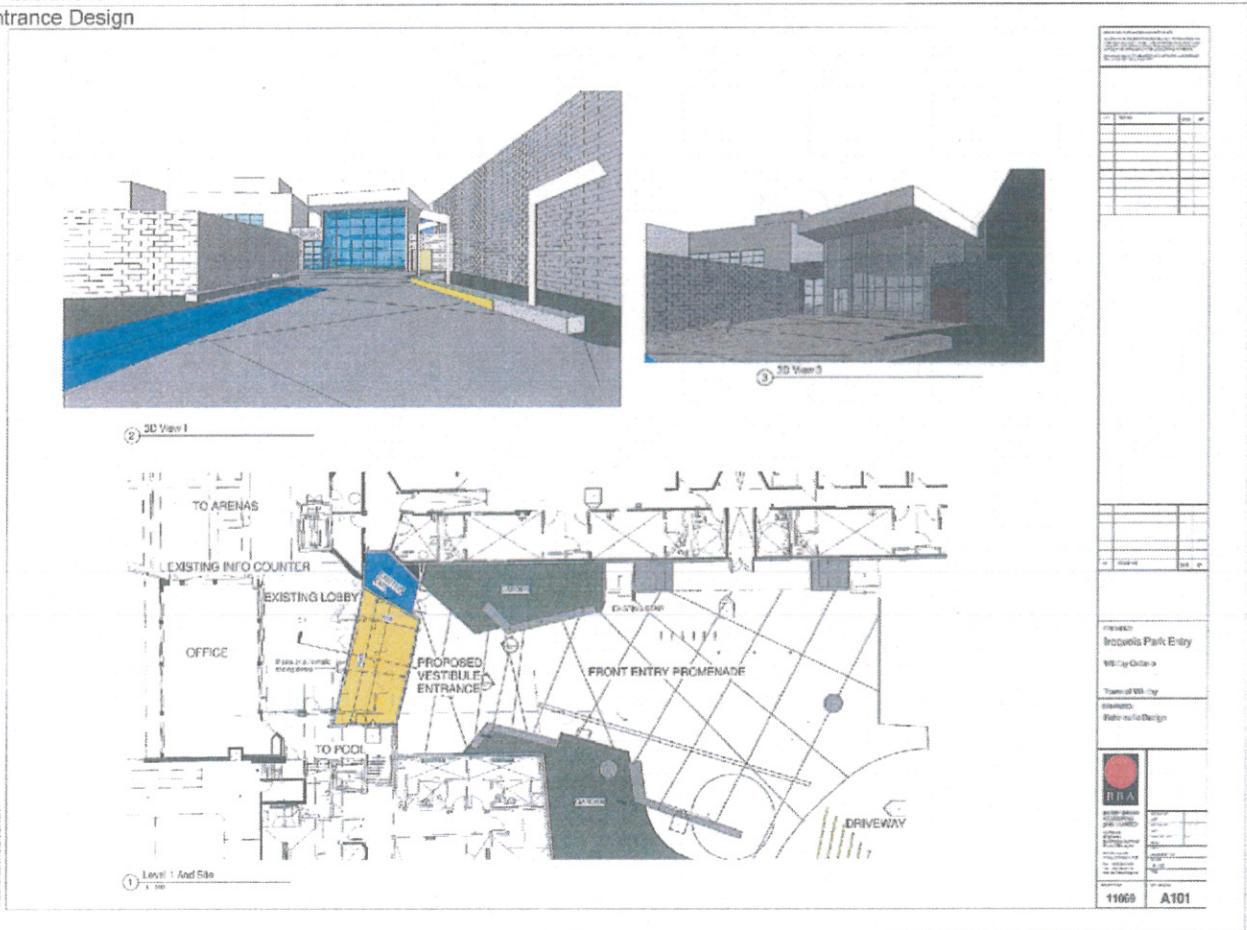
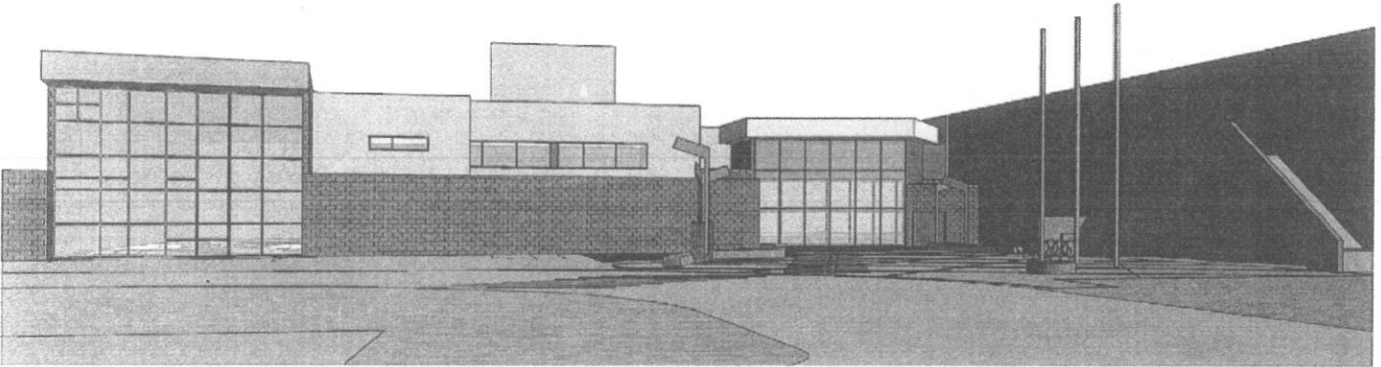
Attachment #1 Proposed Entrance Design and Perspective

The sketches on Attachment #1 illustrate the proposed design solution for changes to the entrance at Iroquois Park Sports Centre.

- The proposed new entry would require a double sliding door configuration similar to the entry at the McKinney Centre. This could not be achieved without widening the overall structure.

- The depth of the vestibule would need to be increased from 2.9 meters to a minimum of 5.1 meters to reduce the direct heat loss through the wider openings. The proposed design positions the exterior wall approximately 2.2 meters further east and out into the walkway area in order to achieve the required vestibule depth.

- The pedestrian travel direction would need to be re-aligned slightly, directing visitors to the right and into a wider, more open part of the lobby space. Although the location of the office/reception area limits the opportunity to create a wider entry lobby immediately inside the entry doors, changing the angle of the overall entry structure could create a more intuitive flow direction into the larger lobby area.

- The entry structure would need to be readily identifiable for all visitors and have a significant height and presence. The structure would also need to be fairly transparent to allow natural light to flow into the interior spaces and artificial light to illuminate the entry walkway area in the evenings.

- The proposed design would require a canopy projection to help reduce the accumulation of the snow at the doorway entry location.

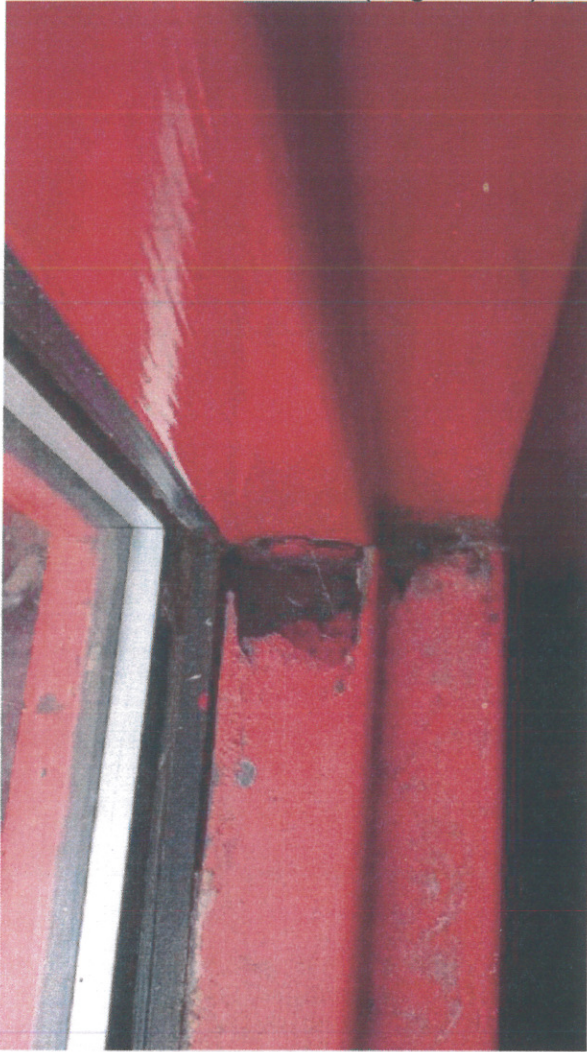
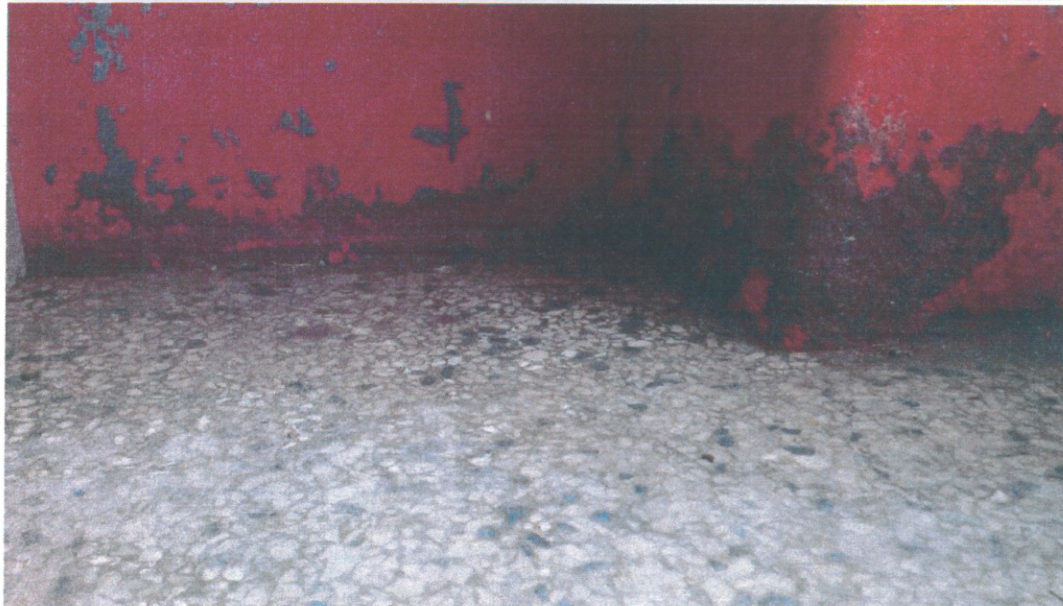
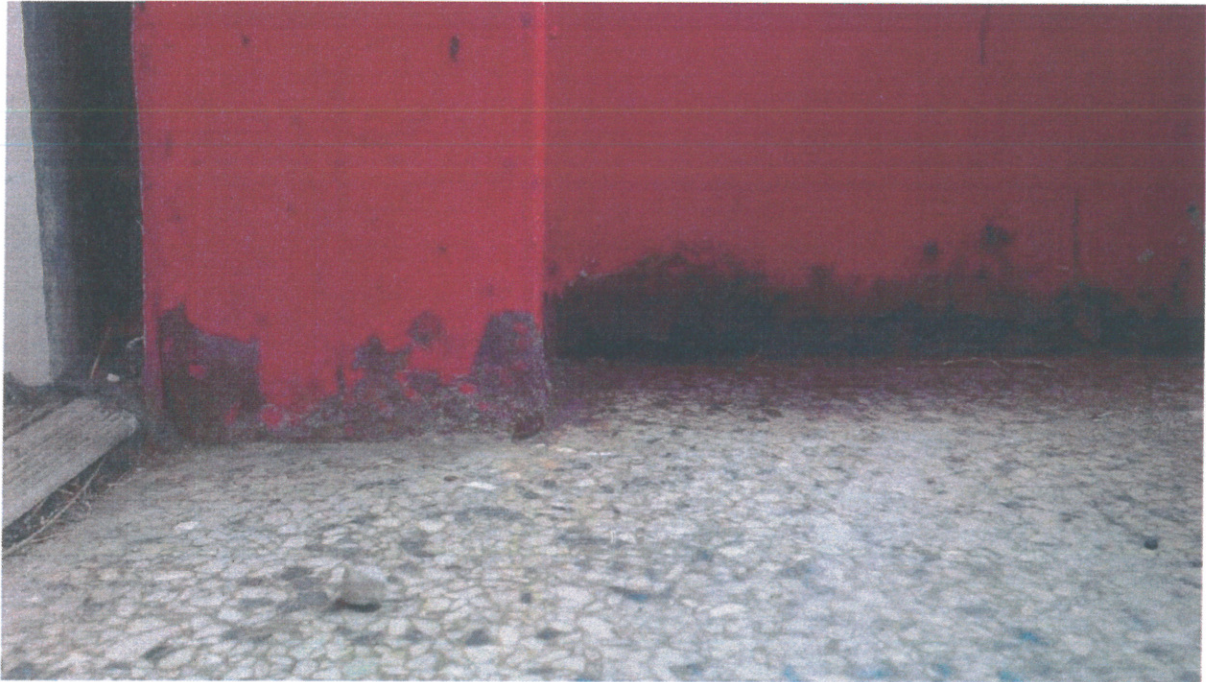
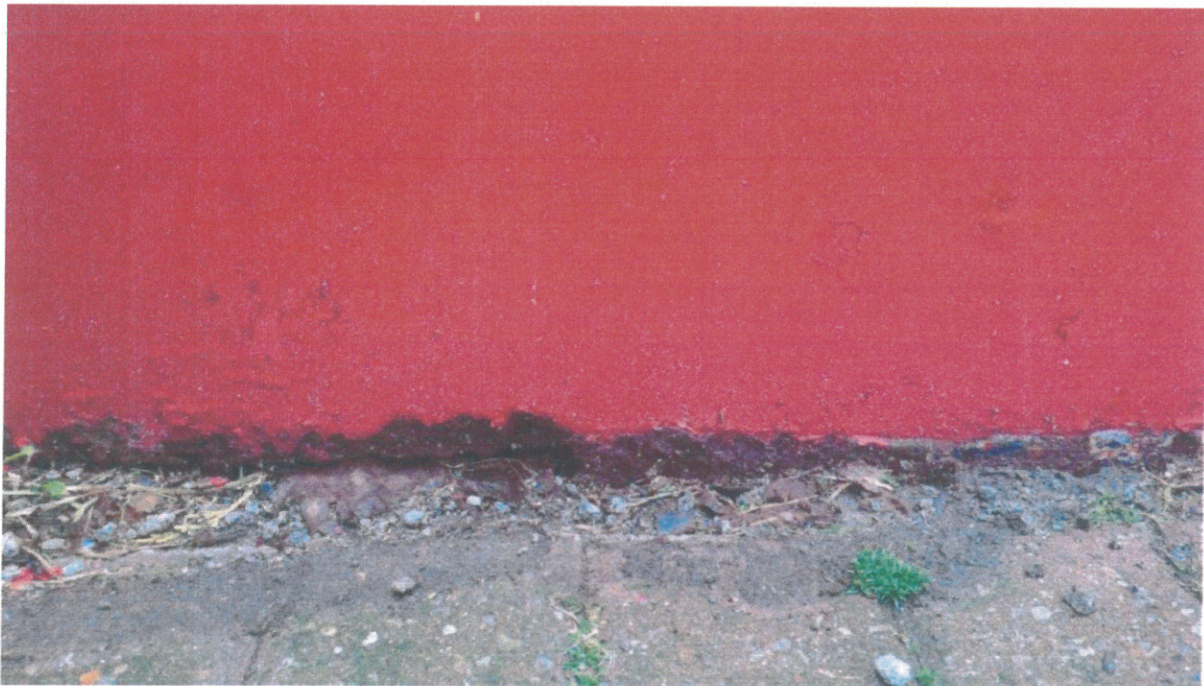
Attachment #2 Photographs showing deterioration of existing structure

The hollow steel section (HSS) and steel window frames that form the main structure for the entrance feature have rusted through in multiple locations. The isolated and accessible rust holes have been repaired many times over the years however the level of corrosion has expanded to include a continuous line of deterioration at the grade level of the columns and beams and will require a much more significant repair in the near future.

The photographs included on Attachment #2 illustrate the nature of the corrosion on the steel frame entry structure.

sliding door configuration. The modification of the existing structure to simply accommodate the sliding door is not recommended given the overall condition of the structure and the congestion concerns identified above. In addition, the installation of automatic sliding doors similar to the entry at the McKinney Centre would increase the overall width of each entry point and the relatively shallow vestibule would result in both the outer and inner doors being opened at the same time allowing considerable heat loss and cold air to move directly into the lobby spaces. The depth of the existing entry vestibule at IPSC is approximately ½ the depth of the vestibule at the McKinney Centre.

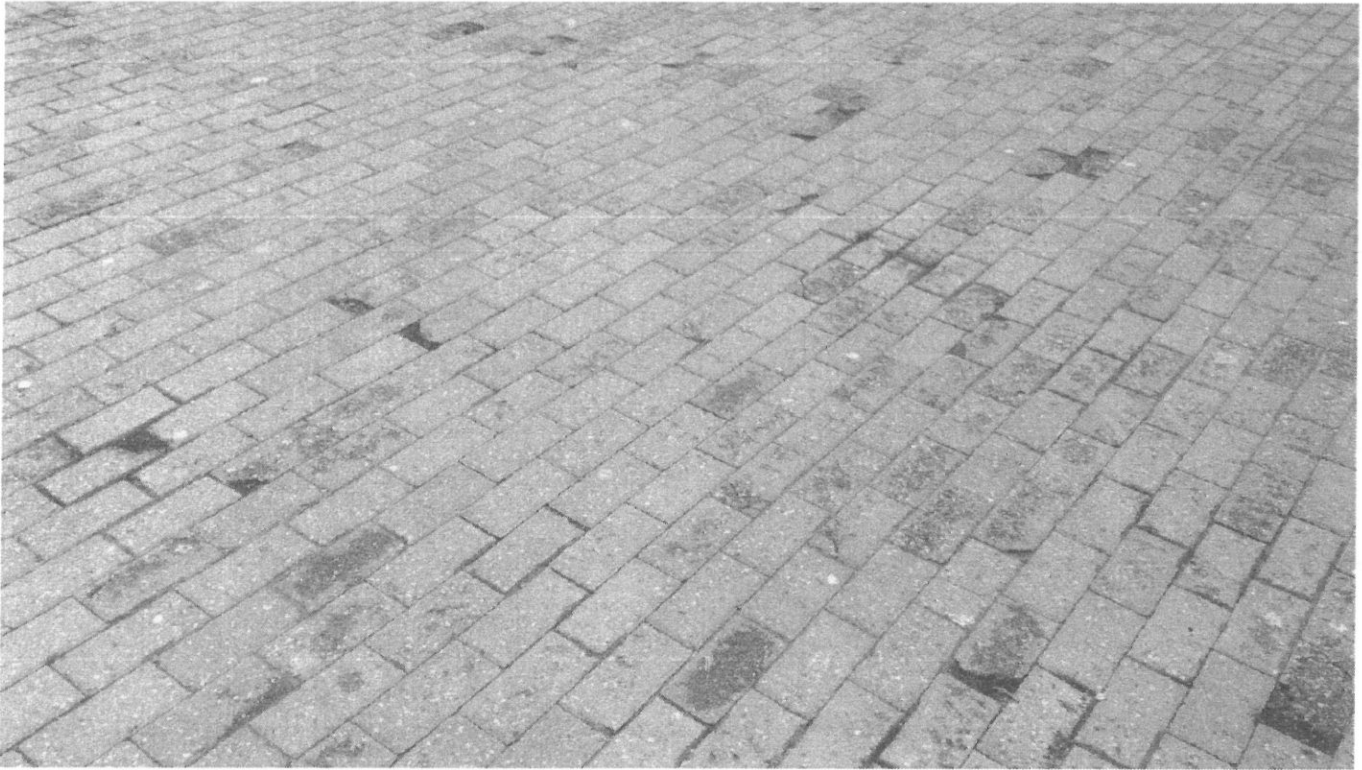
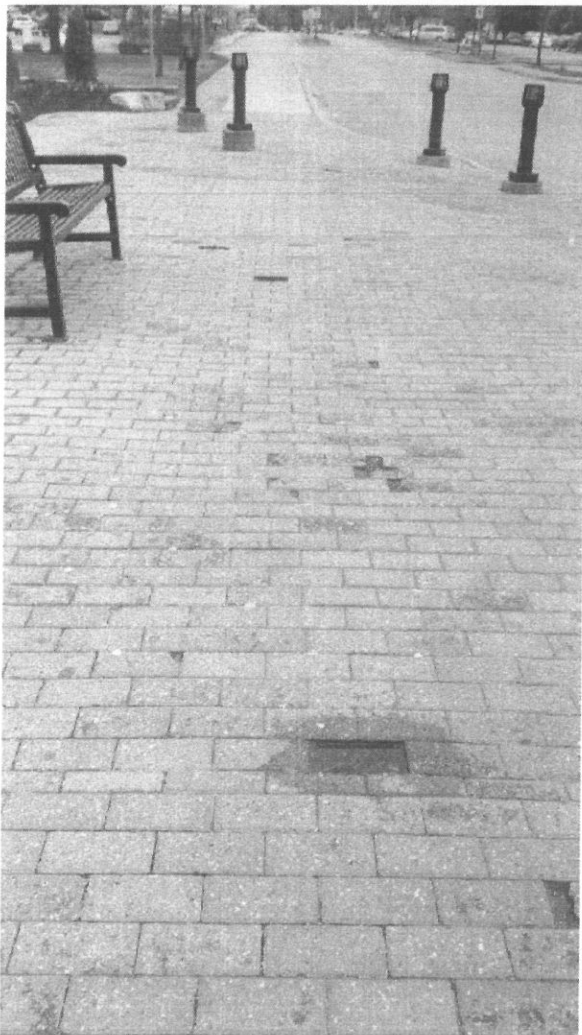
Attachment #3 Photographs showing deterioration of walkway

The paver stone walkway leading to the main entry at IPSC was also installed in 1987 and has required a number of significant repairs over the years. Many of the concrete paver stones have deteriorated and the entire walkway area needs to be removed, and replaced with a poured concrete walkway. The application of de-icing salt over many years has resulted in the salt migrating to the bottom of the paver and causing it to deteriorate from the bottom up. The top surface of the paver stone may look to be in reasonable condition, but upon removal, the bottom third of the paver stone is crumbling. Once removed, the stone cannot be re-used. This condition is evident across the entire entry walkway area.

The photographs included on Attachment #3 will illustrate the level of deterioration of the paver stone walkway that is evident on the surface.

The paver stone walkway is not a suitable surface for pedestrians with mobility limitations due to the potential for unevenness and the need for ongoing maintenance attention. Staff is proposing the installation of a poured concrete walkway to replace the existing paver stone walkway.
